#### 8A No. 1 Hole

#### Articulated Drilling - Project Review

Articulated Well 8B-DDla Well:

# Drilling Summary

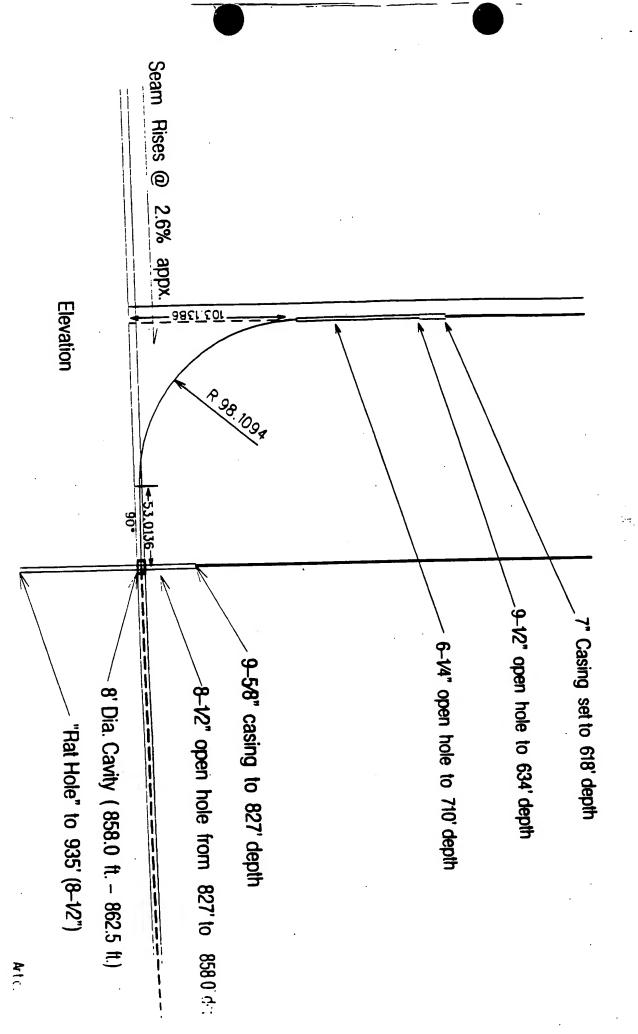
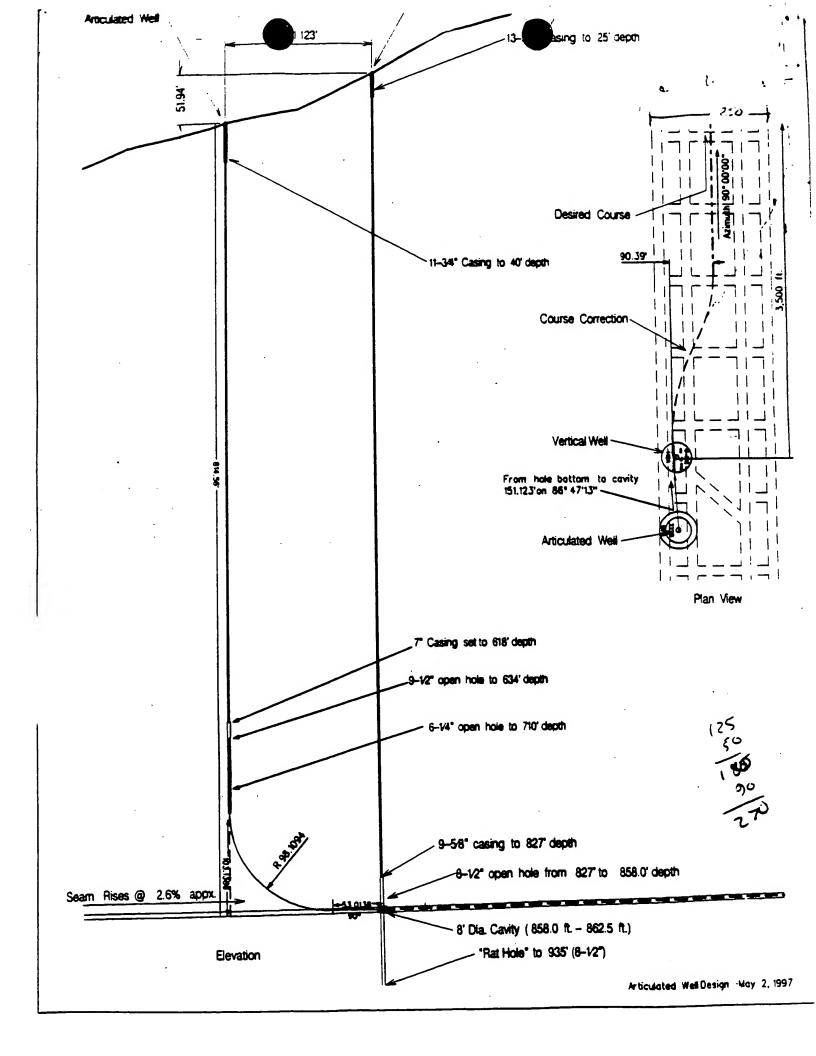
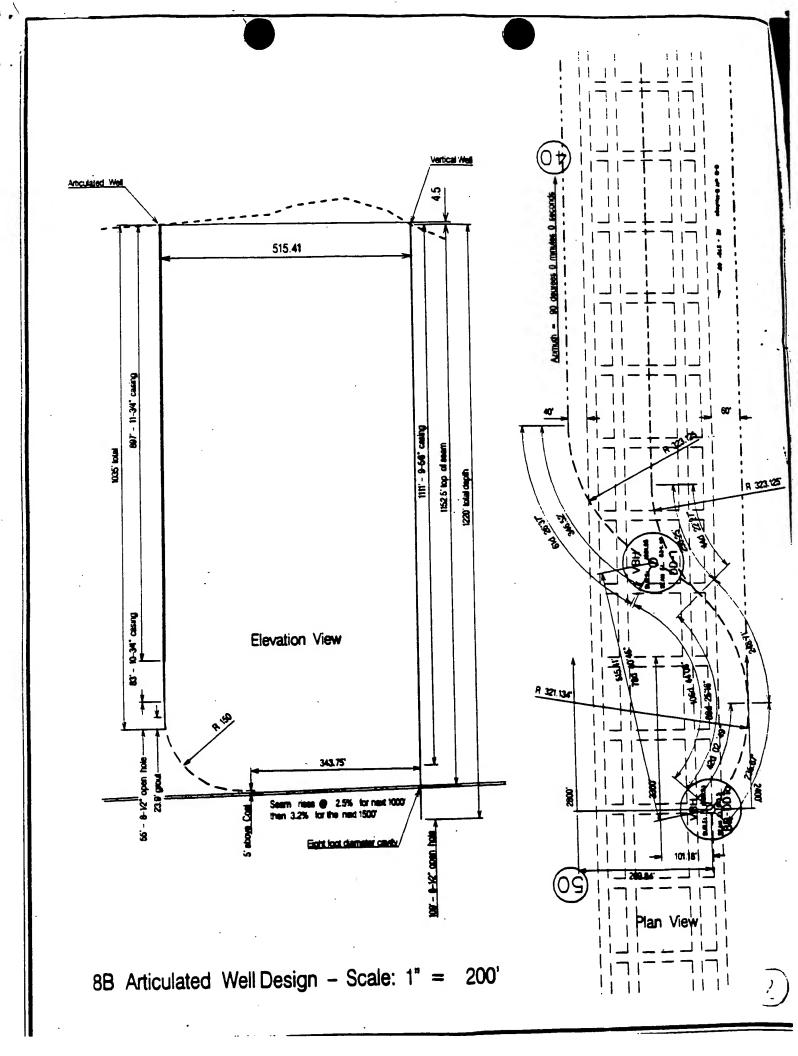
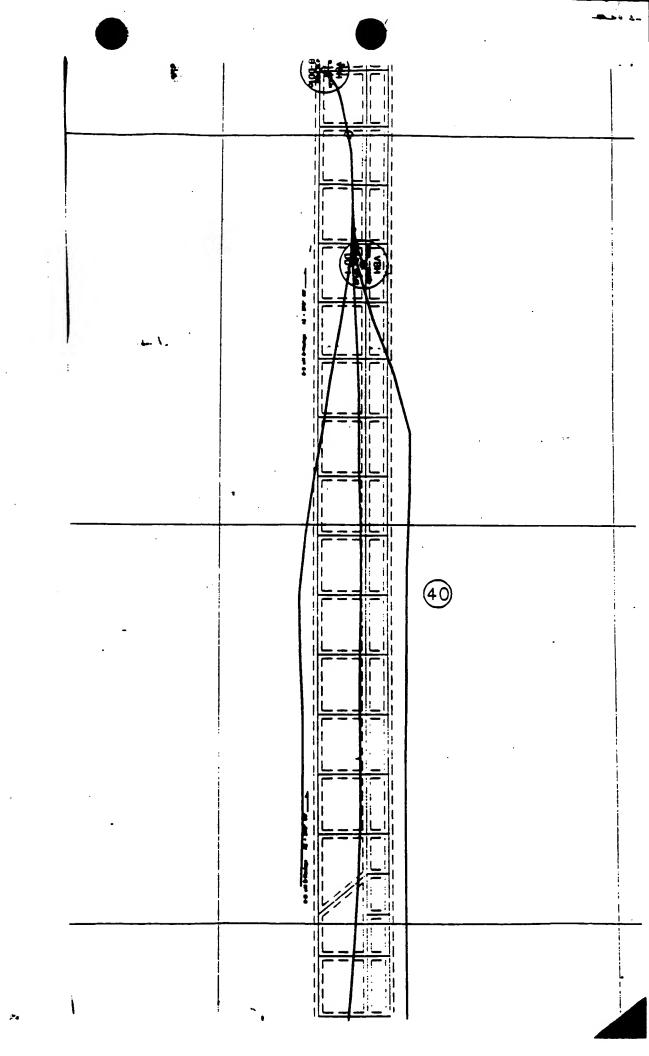
Re: Plan to mine into Articulated Holes on 8A (DW-1)

Current gas production is 160 mcfd (110 cfm) of methane.

Compressor is pulling a vacuum on the hole. The vacuum control valve is set to control the compressor vacuum at the surface to -3.0 psig. This should provide slight pull of mine air into the borehole when mine connection is made.

An oxygen sensor is set to kill the compressor engine at 6% O2 (30% air - 70% CH4). If too much air is pulled into borehole, the compressor will go off, thus allowing the entire gas production to flow into mine.

Computer room may see "high vacuum" alarm at this site. This vacuum alarm is tied to the oxygen monitor, and is set to alarm at 0.9 % O2.

Because of risk of compressor shut down, CM unit should notify the computer room once hole is penetrated so that one of the surface people can go to the compressor location and adjust vacuum if necessary. The vacuum should be set to that necessary to pull slight vacuum into borehole at mine level. There is a 10 minute delay for air that enters the borehole to reach the compressor.

If unacceptable quantities of gas flow from the hole into the mine, use a Tam LD-275 packer (orange and yellow) to plug the hole and seal off gas flow. This packer will inflate to seal the 4.75" diameter hole.

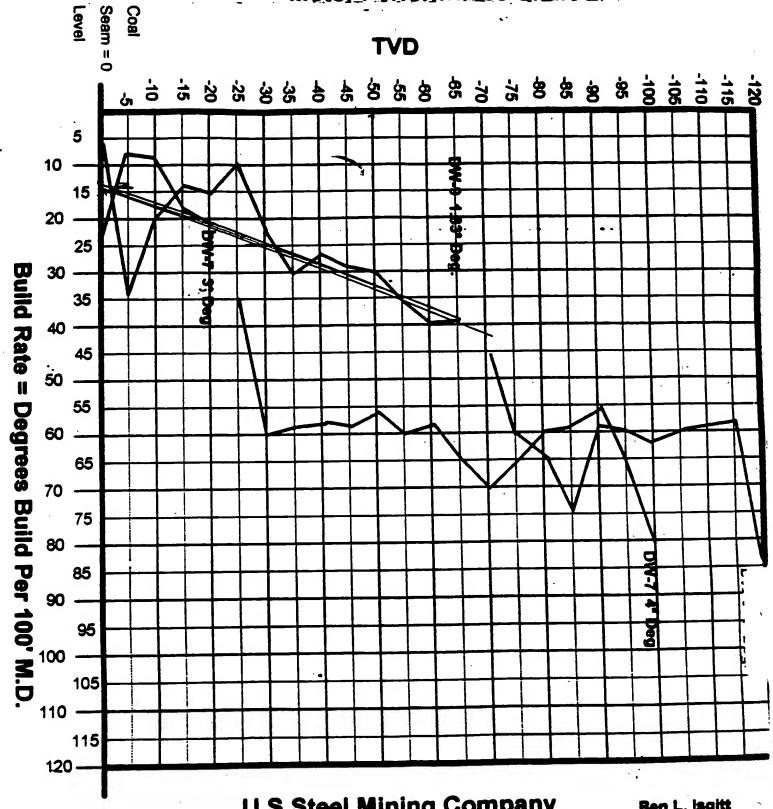
- Blow line (air) from gas buster must be steel. Line must be very short or be restrained.
- When drilling greater than 3000' MD, additional time spent in 15' check shots may be worth while.

- Well becomes over-balanced at 4100' MD (pits loose water). What is annular pressure at this depth?
